# CASE STUDIES

# UPPER RIGHT LATERAL INCISOR

*Case from Dr Peter Fairbairn*

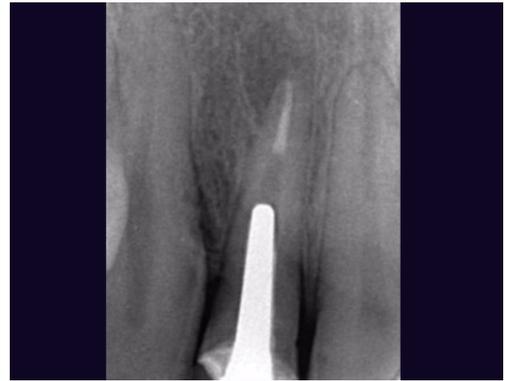
1. Initial situation. Root fracture and bone loss at apical area

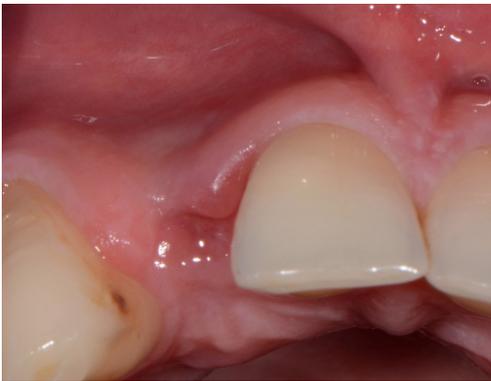
2. 3 weeks post extraction, some papilla loss

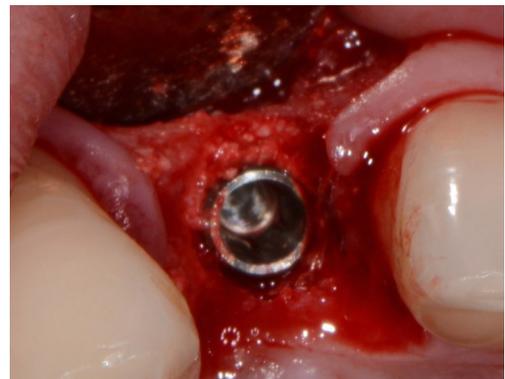
5. 'Wet' mix of EthOss placed palatally. Implant then placed followed by additional 'dry' mix buccally

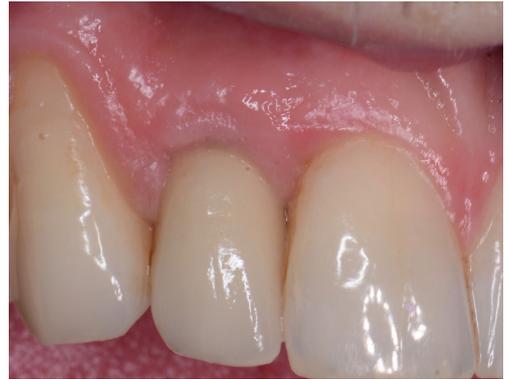
7. Loaded 3 years – nice tissue healing, although little inflammation due to loose abutment

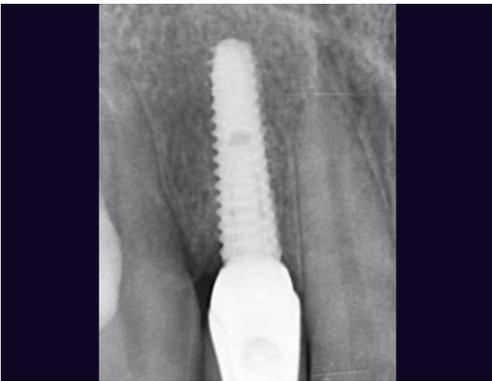
8. Radiograph showing stable site

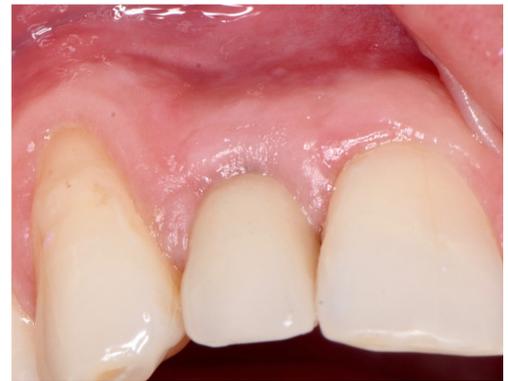
9. Loaded 3 years – note soft tissue healing and papilla recovery
